## HENNEMAN BRIDGE

32-16-2E

CLEPA  
WASHACER  
May 14, 1954

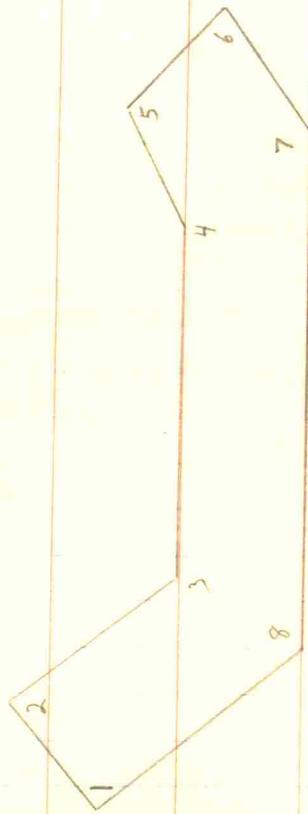
\* Cross-sections from A' to R/W

BM#1	2.28	820.99		818.71
1+00	6.2	814.79		
1+50	4.4	816.59		
2+00	3.3	817.69		
2+50	2.5	818.49		
2+70	2.3	818.69		
3+00	2.1	818.89		
BM#1	2.28		818.71

L	R
R.R. spk. in p.p. S50°W 32' from O+00	
6.4 10 (sh)	6.2 0
8.2 19 BS	5 11 SH
9 10	4.1 9 SH
9 23	3.3 10 SH
8.5 21	2.5 0
2.8 9 SH	2.3 0
	3.1 10 SH
	2.7 10 SH
	8.8 20 BS
	8.4 22 BS

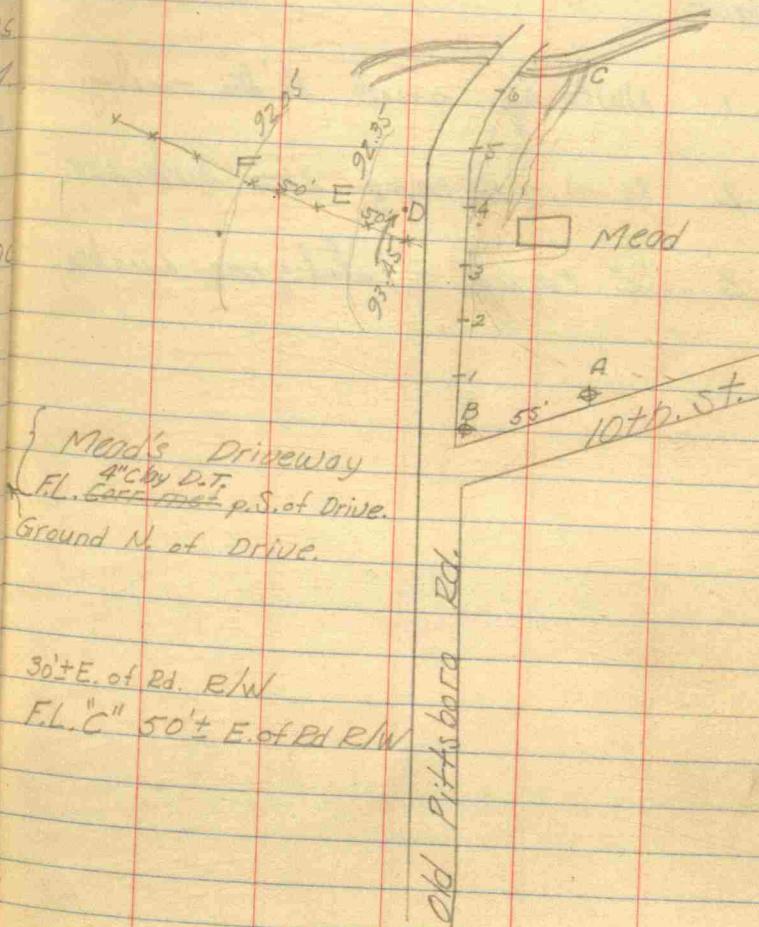
Sta. + H.I. - ELEV.

A	0.88	100.88		
B		100.00	100.00	
1	5.55	95.33		
2	6.85	94.03		
3	7.0	93.88		
4	8.3	92.58		
0	4.27	100.05	5.10	95.78
4			5.10	95.78
5	5.8	94.25		
6	5.5	94.55		
6+50(0)	10.6	89.45		
	11.4	88.65		
D	6.6	93.45		
E	7.7	92.35		
F	8.0	92.05
